The surface element deposition and corrosion behavior study of multi-cutting in the machining of magnesium alloys

Keywords: WEDM-HS, multi-cut, element deposition, carbonization layer, corrosion behavior.

Abstract. The surface element deposition and corrosion behavior of AZ91D magnesium alloys multi-cut with high speed wire electrical discharge machine (WEDM-HS) is studied in this paper. The microstructure and surface morphology of the WEDM-HS surfaces were examined with scanning electron microscope (SEM). Chemical composition of the fabricated surface was analyzed by energy-dispersive X-ray spectroscopy (EDS). Using Tafel polarization curves to evaluate the corrosion resistance. Experimental results show that WEDM-HS multi-cutting process can effectively improve the surface integrity to obtain a flat surface. Carbon and oxygen of the foreign elements were observed after WEDM-HS cutting. Multi-cutting process increased the oxygen element content in the machined surface. The Multi-cutting surface exhibited excellent corrosion resistance property in the 3.5 wt. % NaCl solution.

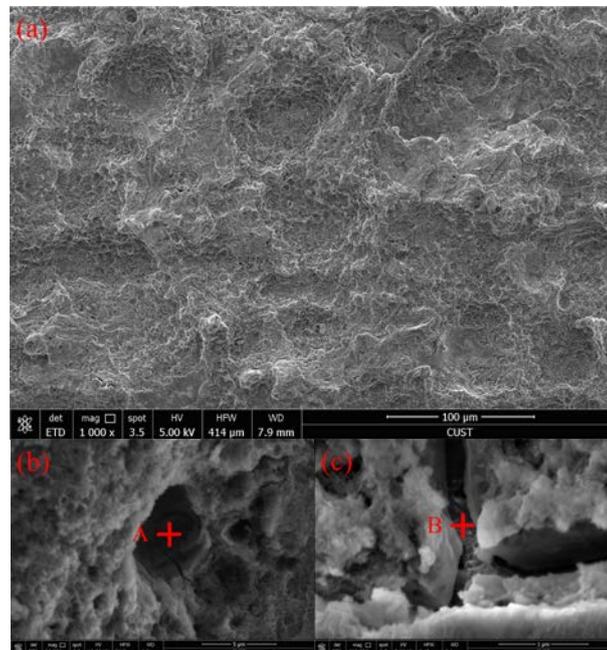
Fig. 1 SEM micrograph of the multi-cutting sample

Surface morphology and chemical composition. Fig. 1 displays the SEM microphotograph of WEDM-HS machined surface after different cutting passes. As shown in Fig. 1a, a rough and porous morphology can be observed on the rough machining surface. According to the rough cutting parameter, AZ91D material was removed with higher pulse duration and power tube numbers. The large erosion craters were left on the machined surface, and we can know that it has big surface roughness values. Because of the high discharge energy, the surface was seriously damaged. Fig. 1b

and Fig. 1c display the local magnification of rough cutting surface (Fig. 1a). The typical defect of WEDM-HS surface micro-cracks and micro-pits are present in Fig. 1b and Fig. 1c respectively.

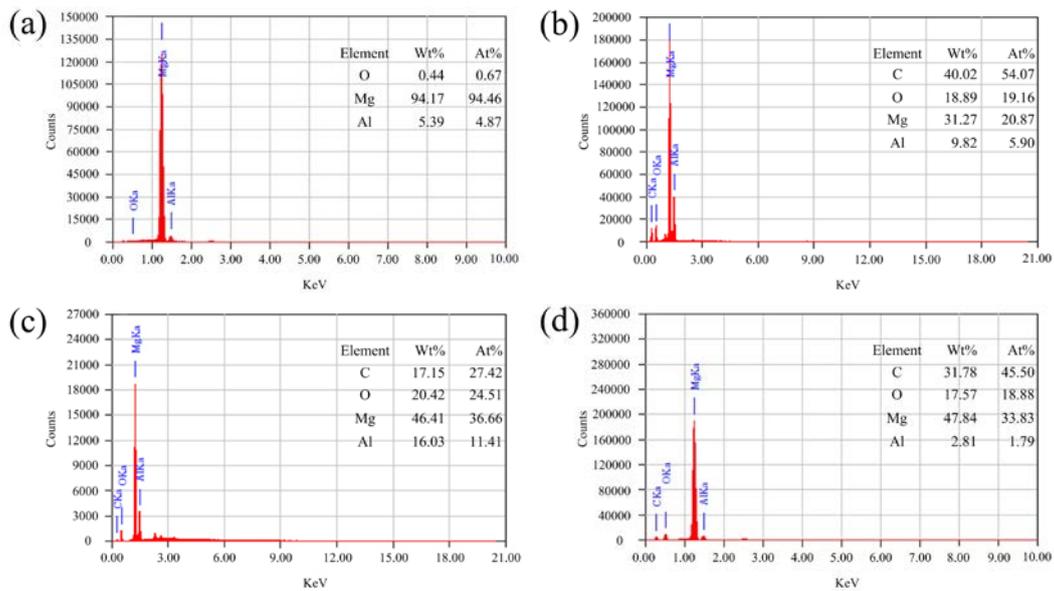
Fig. 2 (a) The EDS analysis of AZ91D matrix and (b) the rough-cutting sample; (c), (d) EDS analysis at the position A, B indicated in Fig. 1a

Fig. 2 shows the EDS analysis results of the AZ91D matrix and WEDM-HS cut surfaces. A typical AZ91D matrix EDS analysis is shown in Fig. 2a, the main chemical elements of matrix were Mg and Al element. However, Carbon and oxygen of the foreign elements were observed after WEDM-HS cutting (Fig. 2b). The elements of Mg and aluminum were significantly reduced in contrast to matrix. Therefore, we believe that it is possible to produce a carbon layer during processing. Generally, in the case of the emulsion as coolant, the cooling liquid is affected by high temperature in the discharge region, and became gas immediately. During the processing, the discharge of black carbon and other material coagulation attached on the processing surface, lead to the processing surface present dark color. Finally, due to the effect of cooling and solidification, causing carbonization layer formed on the material surface [8]. Fig. 2c and Fig. 2d respectively were the EDS analysis results on specific position A and B. Although the rough-cutting surface was seriously damage. In which elements carbon and oxygen were also detected in the bottom of micro-cracks and micro-pits. It indicates the carbonization to occur in infinitesimal area, or even nano level and smaller regions.

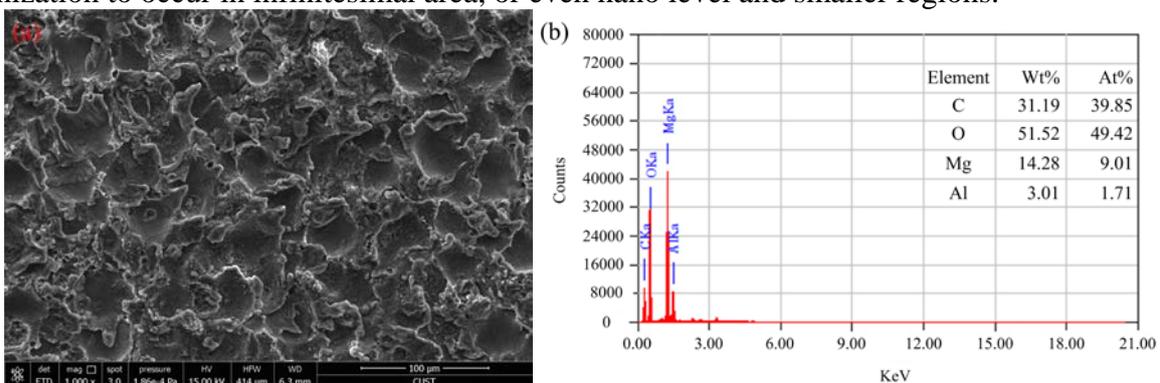
Fig. 3(a) SEM micrograph of the multi-cutting sample, (b) the EDS analysis of multi-cutting sample

Fig. 3a displays the SEM microphotograph of WEDM-HS machined surface after multi-cutting process. The craters size on the machined surface was obviously decreased compared with rough-cutting. Furthermore, the surface integrity was improved signally. At the same magnification, we found that there were fewer micro-cracks and micro-pits on multi-cutting surface. This phenomenon demonstrates that using multi-cutting process has a good consequence in surface integrity and quality, even though magnesium alloys has low density, low hardness, and other

properties. It has good processing quality at the bottom of crater. Use narrow pulse interval to make crater overlap more, and the bottom area of crater was increased relatively in WEDM-HS machined surface.

Fig. 3b presents the chemical elements analysis results of the multi-cutting surface. Comparison of chemical composition elements we found Mg element was decreased, and the oxygen element was increased slightly. During the multi-cutting process, AZ91D Mg alloys were exposed to air in a maximum extent, and dielectric fluid was relatively sufficient. Due to more fully oxidation as a result of high temperature involved in the process. It leads to a change of the elements of the machined surface. In addition, narrowing the pulse interval plays an important role in the carbonization process. Continuous discharge is contributed to the combination of the foreign elements and matrix material.

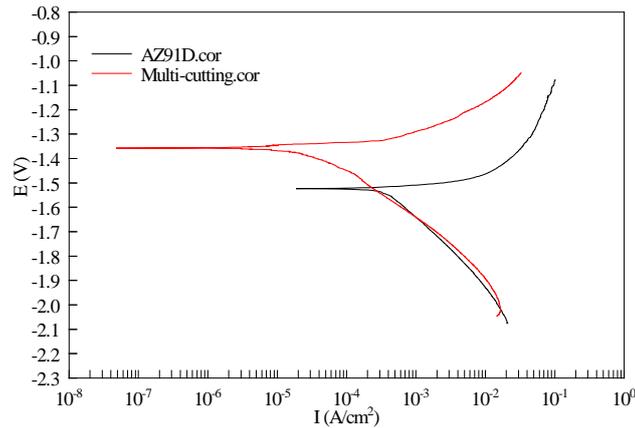
Fig. 4 Potentiodynamic polarization curves of AZ91D matrix and multi-cutting sample

Corrosion measurement. To investigate the corrosion behaviour of AZ91D after carbonization, we used the Tafel polarization curves to evaluate corrosion resistance of the WEDM-HS multi-cutting surface. The Tafel curves of AZ91D with various treatments in the 3.5 wt.% NaCl solution are presented in Fig. 4. Using the ground condition as the reference curve, WEDM specimens exhibited a significantly upward shift in curve. The corrosion potential increases from -1.523 V of the AZ91D matrix to -1.356 V of WEDM-HS machined surface. In the Tafel extrapolation method for measuring the Mg corrosion rate, the corrosion current density, i_{corr} (mA/cm^2) is estimated by Tafel extrapolation of the polarization curve, and i_{corr} is related to the average corrosion rate using [9,10]:

the corresponding corrosion current densities obtained by Tafel fitting are $3.7 \times 10^{-5} \text{ A}/\text{cm}^2$ and $9.3 \times 10^{-4} \text{ A}/\text{cm}^2$ for WEDM-HS multi-cutting and AZ91D matrix, So the P_i of the WEDM-HS multi-cutting workpiece ($8.45 \times 10^{-4} \text{ mm}/\text{y}$) decreases compared with the AZ91D matrix ($2.12 \times 10^{-2} \text{ mm}/\text{y}$). These results indicate that the corrosion resistance was improved obviously after WEDM-HS multi-cutting.

Visible change in current density of the specimens could be attributed to carbonization layer. During the discharge machining process, it can be considered as an Electro-Chemical Machining. The potential of carbon is higher than that of magnesium, and the chemical properties of the oxide is more stable than matrix. As it is clear, the carbonization layer shows the good barrier properties for preventing Cl^- and other harmful ions destroyed the surface. This is a reason for an increase in the corrosion resistance of the AZ91D magnesium alloys. Moreover, the results also may be attributed to the machined surface of conventional WEDM in which an amorphous layer caused by rapid cooling was generated to advance the corrosion resistance.

The results of the potentiodynamic polarization curves (Tafel) show that multi-cutting sample with the low corrosion current density. The carbonization layer acts as the barrier prevent Cl^- and other harmful ions. That means that the corrosion resistance of the AZ91D was improved.
