# Research on the Damage Assessment of Carbon/Epoxy Composite Laminates at Different Impact Energy

**Abstract.** The influence of the impact energy on the impact damage of the carbon fiber fabric reinforced epoxy composites laminates was investigated. Impact tests on the carbon/epoxy composite laminates with the size of 600 mm×700 mm were conducted with different the impact energy levels from 5 J to 65 J at the room temperature, respectively. After the impact test, the impact crater depth and the matrix length was measured on the tested specimens. The calipers and three-dimensional microscope was used to characterize the damage after impact tests. The experimental results show that the impact damage tends to be more severe as impact energy increases. The crack length of the carbon/epoxy composite laminates increases linearly with the increasing impact energy.

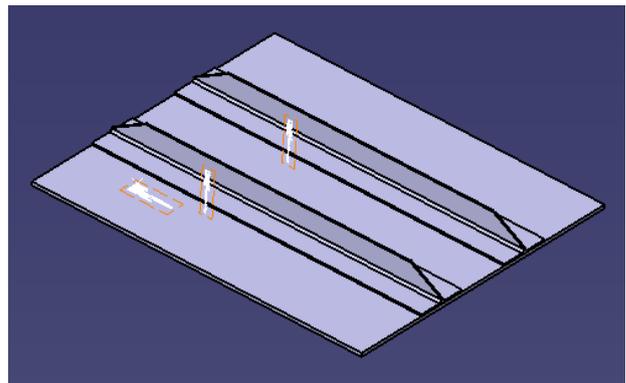
As shown in Figure 1, the carbon fiber/epoxy matrix laminates (600 mm×700 mm) were made by the hand lay-up and cured in an autoclave system. The sequence of CFRP laminates was  $[+45/-45/0/-45/90/+45/0/0/-45/0/90/0/+45/0/90/0/+45/0/0/-45/0/+45/0/0/-45]_s$ .

Figure 1. Image of specimens.

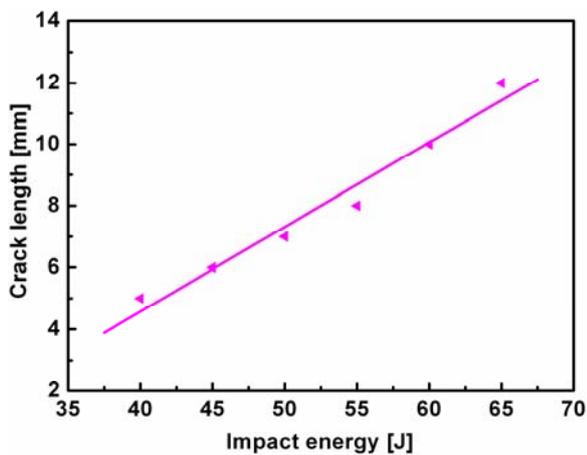
Figure 2 shows that the crack lengths increase linearly with the increasing impact energy. For the specimen, no apparent impact cracks were observed on either side at the impact energy of 5 J to 35 J.

As the impact energy increased to 40 J, the matrix cracks took place in the vicinity of the impact point while no matrix cracks were detected in the opposite impact side of the specimens.

**Figure 2.** The crack length of CFRP laminates versus impact energy.

The crack lengths of the Carbon/Epoxy composite laminates increase linearly with the increasing impact energy.

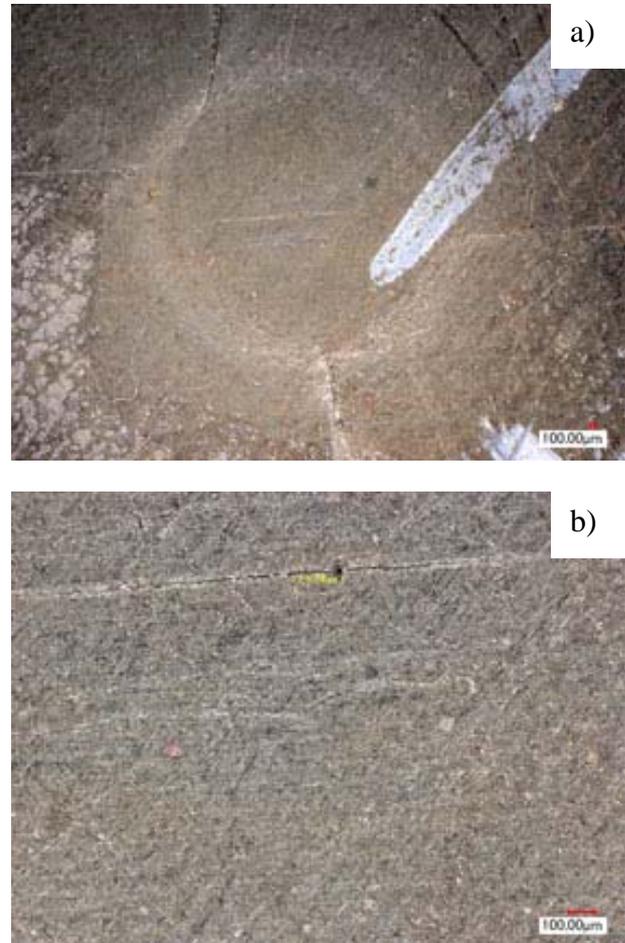
Figure 3 shows that the number and length of the matrix cracks of the impacted specimens on the impacted side at the energy of 55 J.

**Figure 3.** Images of the impact crater at the energy of 55 J. a) the impacted side, b) the opposite side.

Figure 3 to Figure 5 shows that the number and length of the matrix cracks on the impacted side increased as impact energy levels increased. The impact damage of the opposite side tends to be more severe as impact energy increases.

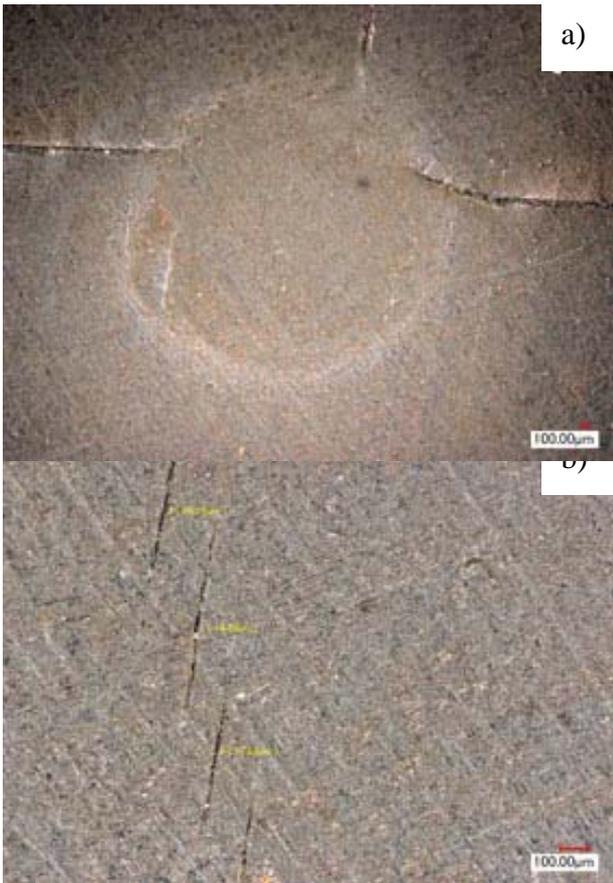
Figure 4 shows that the number and length of the matrix cracks on the impacted side at the energy of 60 J.

**Figure 4.** Images of the impact crater at the energy of 60 J. a) the impacted side, b) the opposite side.

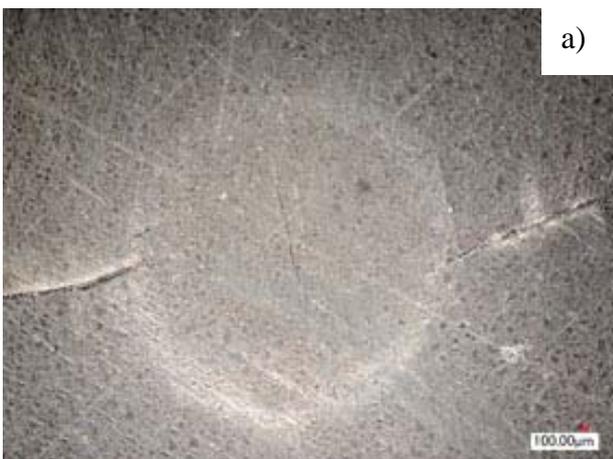
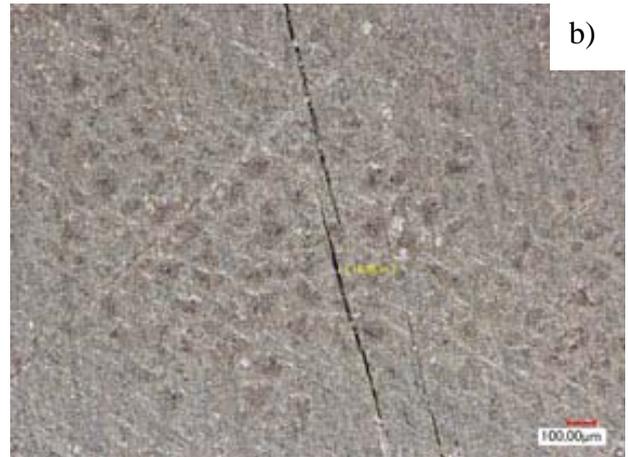
Figure 5 shows that the number and length of the matrix cracks on the impacted side at the energy of 65 J.

**Figure 5.** Images of the impact crater at the energy of 65 J. a) the impacted side, b) the opposite side.

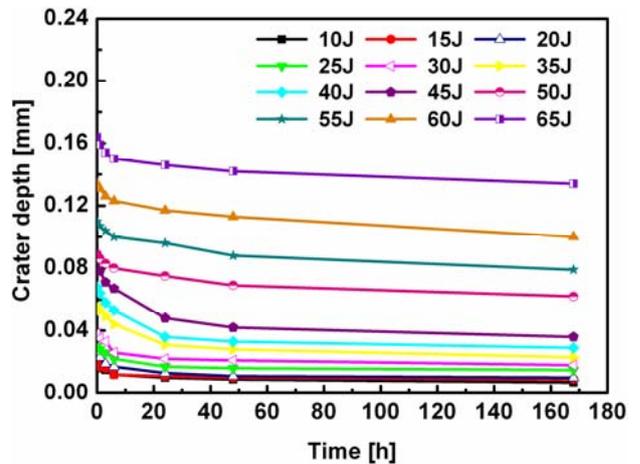
Figure 6 shows the crater rebound value with time. The crater depth was inspected on the impacted surface at 0 h, 1 h, 3 h, 6 h, 24 h, 48 h and 168 h, respectively.

**Figure 6.** Curve of the crater depth of specimens with time

As shown in Figure 6, the crater depth curves of the impacted specimens at different energy levels seem to have two stages. Figure 6 shows that the crater depth decreases significantly before approximately 24 h in the first stage. Then, a progressive reduction of the crater depth is observed in the second stage.

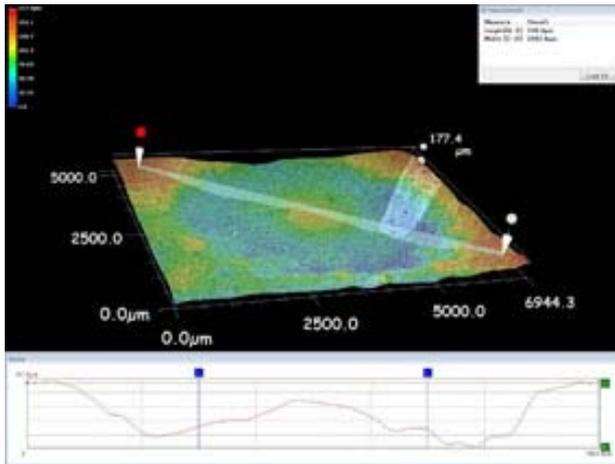
Figure 7 and Figure 8 shows damaged zones of the specimens at the impact energies of 55 J and 60 J.

Figure 7. Impact damage of specimen at the energy of 55 J.

The damaged zones of CFRP laminates at different impact energies were characterized by three-dimensional microscope as shown in Figure 7 to Figure 9.

Figure 7 to Figure 9 shows that the impact area and crater depth of the specimens increase with increasing impact energy.

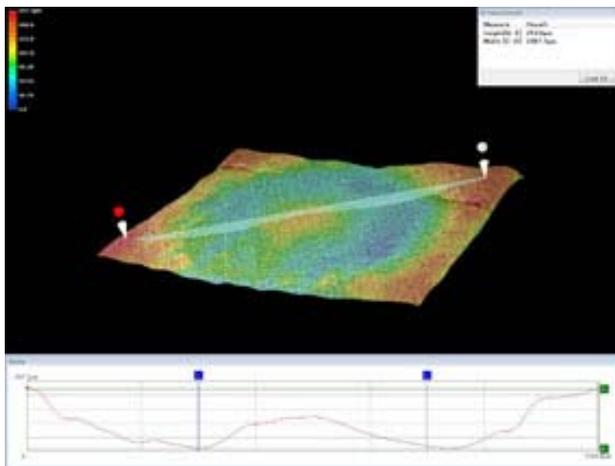
Figure 8. Impact damage of specimen at the energy of 60 J.

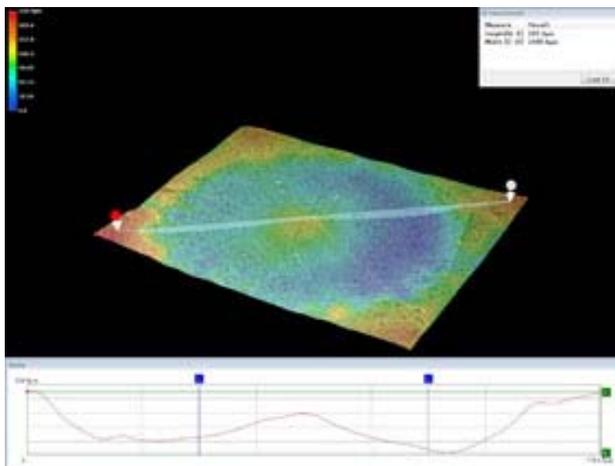
Figure 9 shows damaged zones of the impacted specimen at the impact energies of 65 J.

Figure 9. Impact damage of specimen at the energy of 65J.
