# Real-time monitoring of the full-scale flat-plate floor subjected to fire by acoustic emission and energy rate analysis

**Keywords:** Acoustic emission; *b*-value; Concrete spalling; The flat-plate floor

**Abstract.** This paper presents test results of mechanical behavior, failure pattern and energy rate of full-scale flat-plate floor subjected to fire. The experimental results show that crack patterns on top surface of the flat-plate floor under fire consistent with those at ambient temperature. The experimental results also show that concrete spalling has a significant impact on fire resistance of the flat-plate floor. Serious spalling would directly cause failure of concrete structures or members under fire even though they haven't reached their fire resistance. On the basis of experimental results, acoustic emission parameters were analysed, which proved that energy rate has a close relationship with the damage variation rate of the slab and can be used to estimate the damage process of the flat-plate floor under fire.

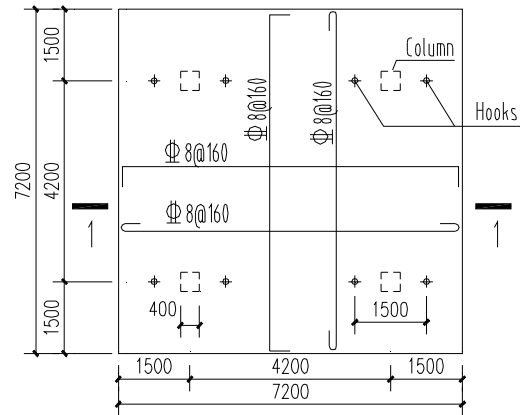
Fig. 1 Arrangement of reinforcement in slab (dimension in mm)

The flat-plate floor specimen was tested at Shandong Jianzhu University in Jinan, China. The slab measured 7.2 m wide by 7.2 m long and the thickness was 150 mm. The column distance was 4.2×4.2 m and the column size was 0.4 m×0.4 m× 3 m. The arrangement of reinforcement of the flat-plate floor is shown in Fig. 1 to Fig 3. The flat-plate floor was loaded with a constant uniformly distributed load and heated on the underside with the ISO 834 standard fire curve [9].

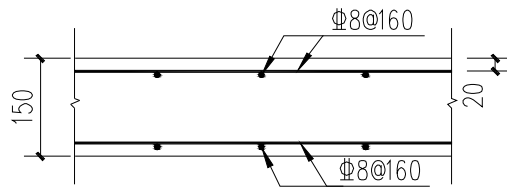
Fig. 2 Details for section 1-1

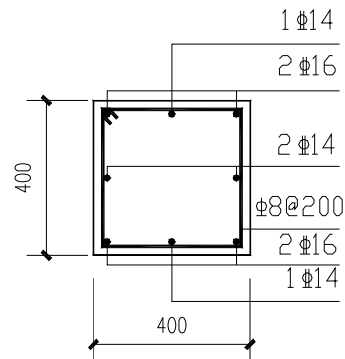
Fig. 3 Reinforcement arrangement of columns

Grade 3 hot-rolled reinforcing bars of 8 mm diameter were arranged at 160 mm spacing along both of the two directions. The clear cover was 20 mm for reinforcement. The yield strength and ultimate strength were 515 and 591 MPa, respectively. The yield strength and ultimate strength of bars in column of 14 mm diameter were 413 and 505 MPa respectively. And the yield strength and ultimate strength of bars in column of 16 mm diameter were 384 and 511 MPa respectively. Commercial normal weight concrete was used for the flat-plate floor and the specified compressive strength was 30 MPa. The cubic compressive strength was 32.6 MPa. The concrete moisture content, when tested, was 4.33%.

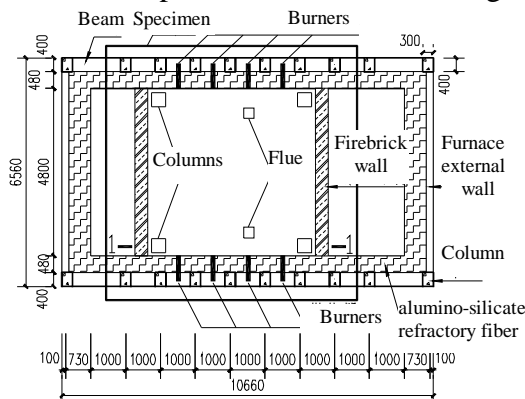
Fig.4 Arrangements of the specimen

The arrangement of the specimen in fire-test furnace was shown in Fig.4 and Fig.5. The heated slab served as the upper cover of the furnaces. It is worth noting that there was a 200 mm-thick flexible space, which sealed with alumino-silicate refractory fiber, between the furnace wall and the bottom of the heated slab so that the edges of the slab were free to deflect during the test. Further details for the test setup of the flat-plate floor fire tests were given in Ref. [8].

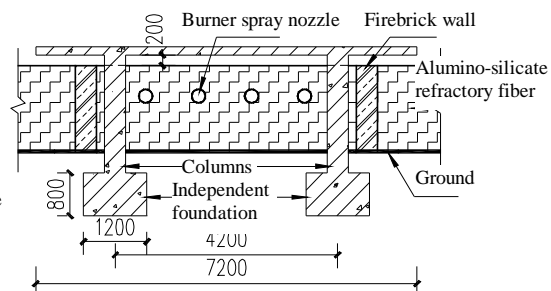
Fig.5 Details for section 1-1

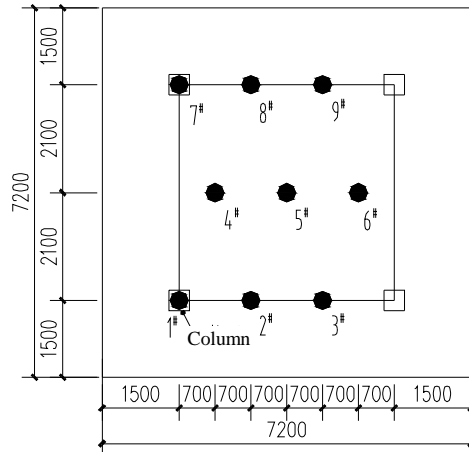
Fig.6 Distribution of AE sensors

Nine type-SR50A Acoustic Emission (AE) sensors were placed on the top surface of the slab and the arrangement was shown in Fig.6. Magnetic ring at bottom of the AE sensor is used to strengthen the connection between the sensor and specimen. But it is useless for the connection between the sensor and concrete material. In order to get true and effective data, wave-guiding rod was used in the test and the detail installation is shown in Fig. 7.

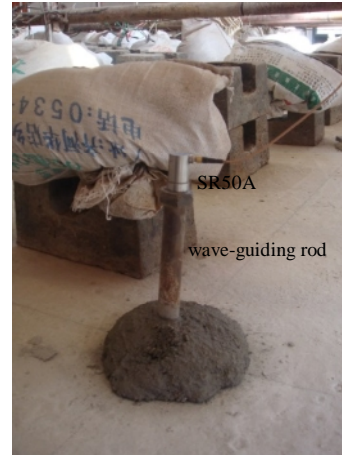
Fig.7 Fixed AE sensor

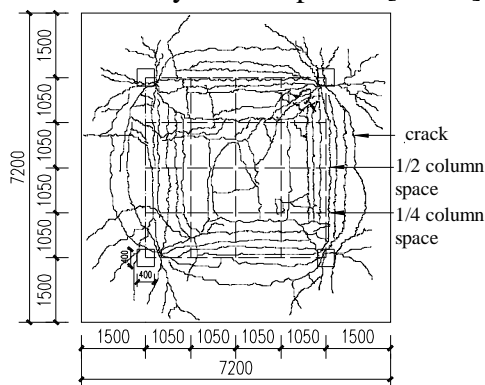
Fig.8 shows the top view of the concrete slab after the fire. During the early stages of the fire, oblique cracks of 45 degree with axis between columns rapidly formed beside the four columns. At 5 min, cracks parallel to the axis between columns formed, all the cracks about 0–50 mm inside of the axis and propagating to the column direction. At 7 min, cracks parallel to the axis between columns formed, these cracks about 350–550 mm outside of the axis and propagating to the column direction and finally crossed with the oblique cracks emerged at beginning. At 9 min, cracks parallel to the axis between columns formed, all these cracks about 350–550 mm inside of the axis and propagating to the column direction. At 44 min, there were 5 cracks inside of every axis and finally the failure pattern of the flat-plate floor under fire was formed as shown in Fig.8. The failure pattern consistent with those at ambient temperature, so it can be assumed that the yield-line pattern at elevated temperatures should follow the conventional yield-line pattern[11-12].

Fig.8 Top crack pattern of the flat-plate floor

- (1) Based on the full-scale tests, the crack patterns on the top surface of flat-plate floor consistent with those at ambient temperature, so it can be assumed that the yield-line pattern at elevated temperatures should follow the conventional yield-line pattern.
- (2) For concrete structure, the concrete spalling has a significant impact on the AE monitoring especially in case of the concrete has a high moisture content.
- (3) Monitoring of the flat-plate floor subjected to fire by energy rate can easily find the cracks generating and developing processes and judge the damage degree of the slab, but it can't find the accurate occur time of every crack.

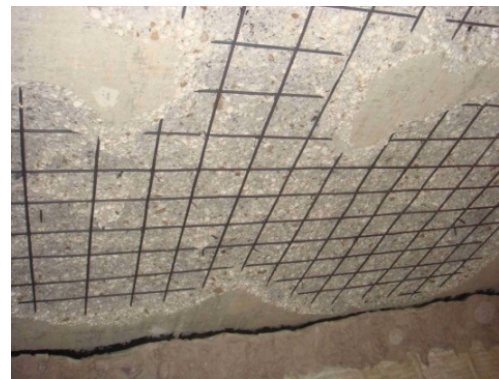
Fig.9 Bottom failure of the specimen

Fig.9 shows the bottom view of the slab after fire; severe spalling occurred and a large portion of reinforcing bars showed, corresponding to occurrence of big popping noises and noticeable vibration during the test. Examination of the reinforcing bars showed that the bars at the bottom had not ruptured.

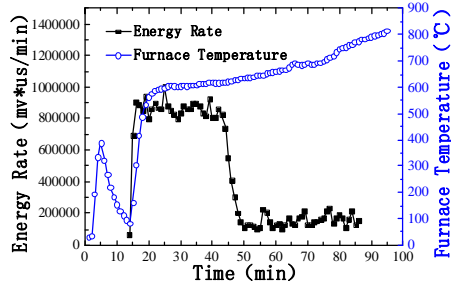
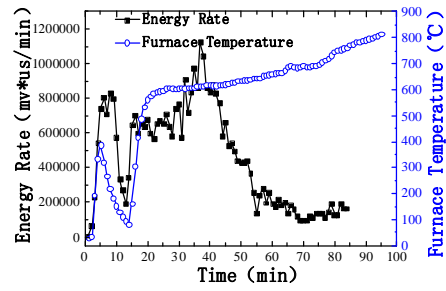
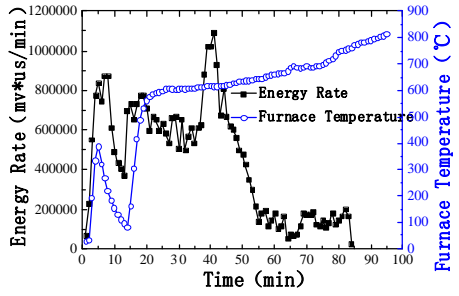
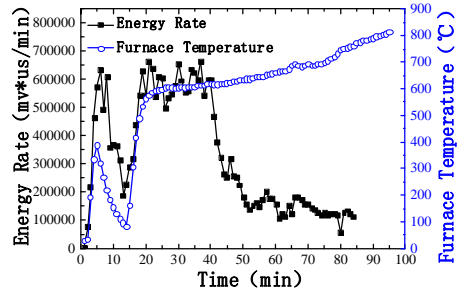
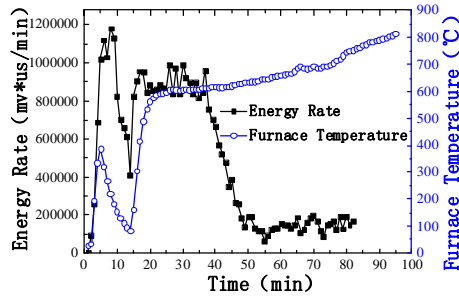
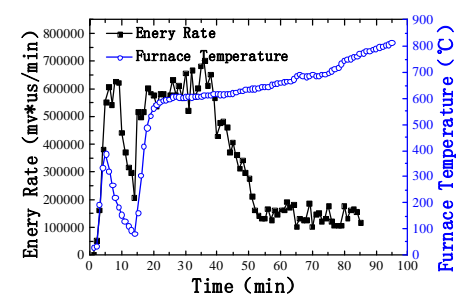
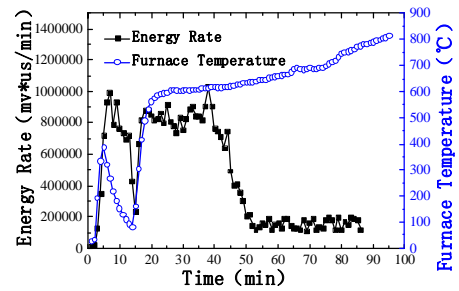
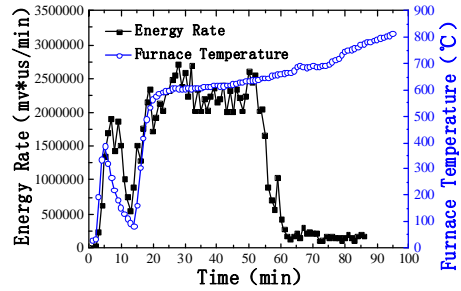
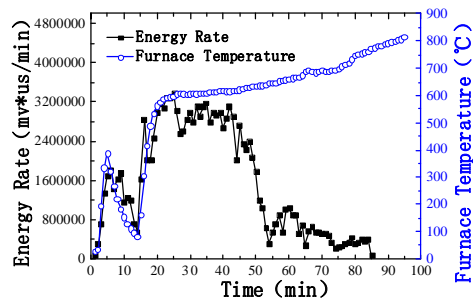
a)Energy rate variation of sensor 1<sup>#</sup>

b)Energy rate variation of sensor 2<sup>#</sup>

c)Energy rate variation of sensor 3<sup>#</sup>

d)Energy rate variation of sensor 4<sup>#</sup>

e)Energy rate variation of sensor 5<sup>#</sup>

f)Energy rate variation of sensor 6<sup>#</sup>

g)Energy rate variation of sensor 7<sup>#</sup>

h)Energy rate variation of sensor 8<sup>#</sup>

i)Energy rate variation of sensor 9<sup>#</sup>

Fig.10 Variation of the energy rate

The energy rate means energy generated per minute by cracks development. High energy rate means cracks generating and developing fast, so the higher energy rate represents more serious damage occurred to the flat-plate floor under fire. Conversely, the lower energy rate represents less damage occurred to the flat-plate floor under fire. So energy rate can be used to estimate the damage of the flat-plate floor under fire. The energy rate and furnace temperature variations were shown in Fig.10.

The energy rate increased rapidly at beginning of the test and got the highest value at 4 min, means that the micro-cracks inside of concrete developed fast and the highest energy rate corresponding to the appearance of oblique cracks at 4 min. After 4 min, the energy rate decreased because of the test stopped and it increased again at 6 min when the test restarted. The energy rate kept high values from 14 min to about 40 min, but that didn't mean the endless of cracks occurred. In fact, the phenomenon was caused by cracks development and concrete spalling. In this test, the flat-plate floor was poured in winter and the curing time was about 6 months, and the flat-plate floor kept high moisture content till the test carried out because of the comprehensive effect caused by all of the influence factors. And finally the high moisture content caused serious concrete spalling when tested. The energy rate decreased rapidly from 40 min to about 55 min, means that there nearly no new crack emerged in this phase, and the energy generated only because the development of existed cracks. From 55 min to the end of the test, the energy rate kept stationary.
