Research on Mechanism of Distribution Line Failure Caused By Violent Typhoon

Abstract. Distribution line failure caused by violent typhoon is studied in the paper. Violent typhoon is always accompanied by wind, rain as well as even thunder and lightning. Distribution line failure is sorted in the paper. Distribution line failures are divided into two major categories of electrical failure and mechanical failure according to mechanism. Lightning-caused lightning stroke, wind-caused wind age yaw flashover and rain-caused insulation wet flashover are mainly studied aiming at electrical failure. Tower damage and foundation damage are mainly analyzed aiming at mechanical failure. The research results of the paper can provide theoretical basis for analyzing distribution line failure in violent typhoon disaster regions.

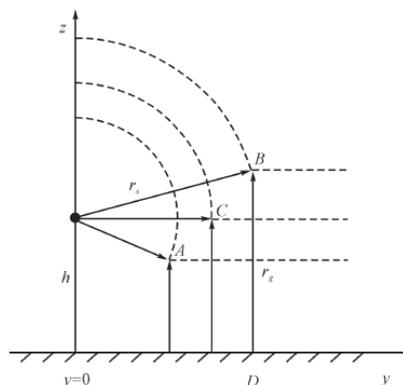
Fig. 1 Electrical geometric model

It is assumed that thunder and lightning can develop vertically downward approximately in a large number of studies. As overhead lines are higher than the ground, they have an attractive effect on thunder and lightning precursor. If the electric field intensity thereof with the line reaches the critical breakdown field strength of air, namely the distance between them reaches a certain fixed value, the line will suffer lightning stroke, the fixed value is defined as lightning stroke distance in the development of thunder and lightning precursor head to the ground. The model recommended by IEEE is used as shown in figure 1. The calculation formulas of conductor and ground lightning stroke distance are respectively shown as follows:

$$\begin{aligned} r_s &= 10^{0.65} \\ r_g &= 0.9r_s \end{aligned} \tag{1}$$
