Safety Inspection and Assessment on a Light Steel Portal Frame Workshop

Abstract. Combining with a light steel portal frame workshop, the safety inspected and assessed through the detections and design checking which had higher practical reference value for similar structures.

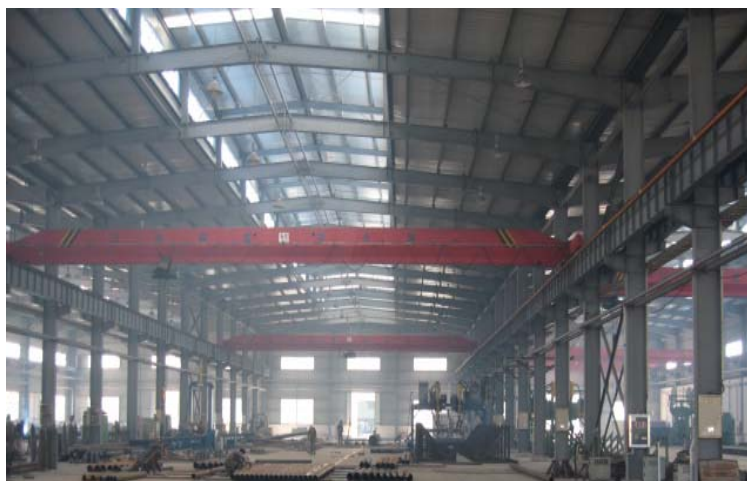
Fig. 2 Inner Structural Arrangement

This engineering was monolayer form of light steel structure. Load-bearing structure of the portal frame, the Span of 78m (three cross), and the length of 102m, The roof system uses glass cotton double-layer color steel roof and put into use in 2007. In order to understand the status of project quality and safety of the light steel plant safety assessment. The layout showed in figure 1. The inner structural arrangement showed in figure 2.
