# Methods of the Restoration of Wooden Architectural Monuments in Russia\*

Andrei Bode

**Abstract**—Monuments of wooden architecture constitute a significant and valuable part of the architectural heritage of Russia. Work on their preservation has its own specifics, due to the material and its properties. The article deals with the methods of restoration of historical wooden buildings. The main trends in the Russian restoration practice are noted. Examples illustrating various restoration methods and approaches are analyzed. The advantages and disadvantages of each of the considered restoration methods for wooden objects are revealed. The criteria for assessing the quality of implemented restoration solutions are the accuracy and authenticity. Restoration correct results on the majority of monuments of wooden architecture give the application of an analytical method.

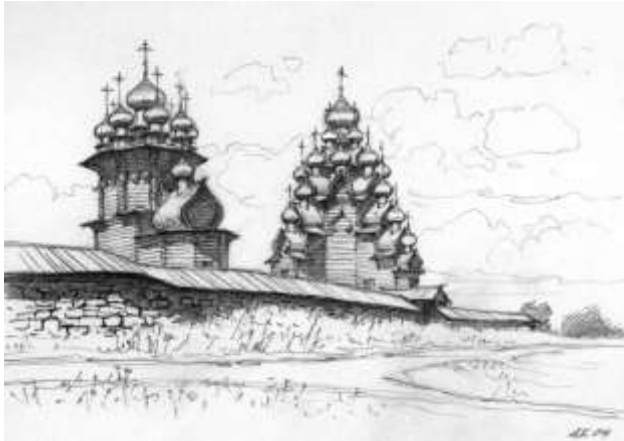
Fig. 1. The Kizhi pogost complex (17th-18th centuries) (Picture of the author).

The most significant restoration projects of the post-war years were carried out on the Dormition Church in Kondopoga (1774), the Dormition Cathedral in Kem' (1711–17), the Kizhi pogost complex (XVII–XIX centuries, see Fig. 1), the Church of the Virgin from the village of Kholm (XVIII centuries), and the Transfiguration Church from the village of Spas-V žhi (1713).

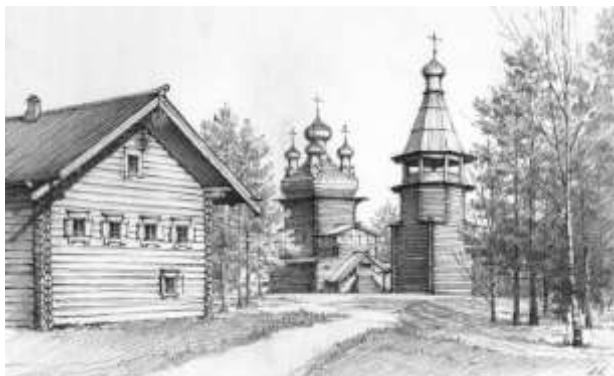
Fig. 2. Church of the Ascension from the village of Kushereka (1669) in open-air museum "Malyie Korely". (Picture of the author).

Particularly strong alterations were made during the restoration of architectural monuments that were being moved to open-air museums. The dismantling of a structure opened up extensive opportunities to replace and reconstruct lost parts of a building. The re-sited churches of the Nativity of the Virgin from the village of Perëdki (early 16th century), of St. Nicholas from the village of Vysokii Ostrov (18th century), of the Ascension from the village of Kushereka 1669 (see "Fig. 2") and of St. George from the village of Verzhina (1672), have a large number of dubious reconstructions made on the basis of marks on the walls or by analogy.

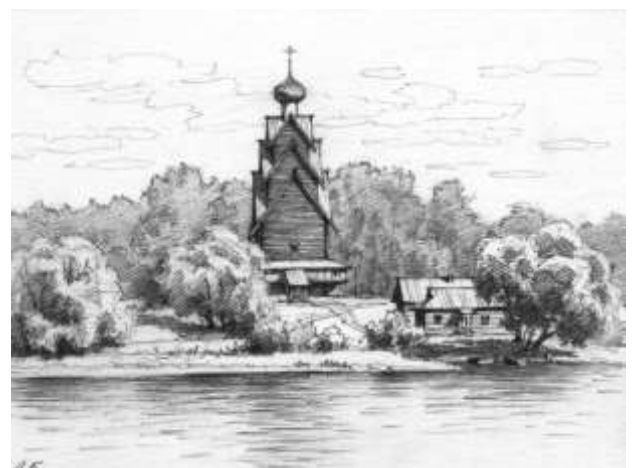
Fig. 3. Church of John the Baptist in the village of Shirkovo (1694). (Picture of the author).

In all-of-a-piece restorations, major removals remain quite frequent. For example, in the cases of the Church of John the Baptist in the village of Shirkovo 1694 (see "Fig. 3") and the Church of the Prophet Elijah in the village of Samino (1692), to achieve a harmonious appearance the bell towers built on in the 19th century were removed.

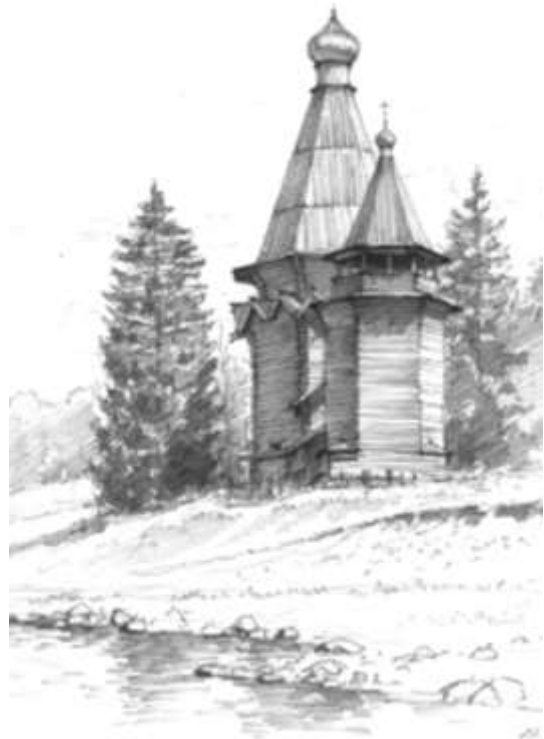
Fig. 4. Church of St. Nicholas in the village of Soginitsy (1696). (Picture of the author).

The Church of St. Nicholas in the village of Soginitsy 1696 (see "Fig. 4") was also reconstructed over the course of its history. The church and bell tower were built at different times. During the restoration the main part of the church was completely returned to its original appearance, but the later cladding was retained on the bell tower along with the later treatment of the belfry stage. Different restoration approaches were applied to different parts of the ensemble. The resultant contrast is softened by the fact that the church is separated from the bell tower by an open porch.

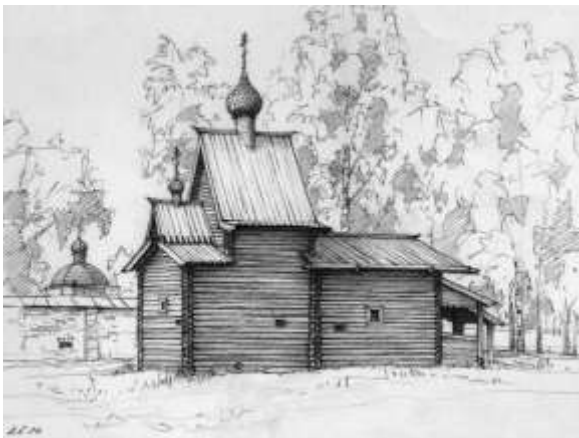
Fig. 5. Church of the Deposition of the Robe from the village of Borodava (1485) before the restoration in 2010. (Picture of the author).

The Church of the Deposition of the Robe from the village of Borodava 1485 (see "Fig. 5") was moved to the compound of the Kirillo-Belozerskii Monastery. It was refashioned many times and has been restored more than once. During the first restoration, the cladding and metal roofs were removed. At the time of the 2010 restoration further research was carried out. On the basis of traces, various types of nail-less roofs were recreated. However, there are no analogies for such nail-less roofs and details in any known Russian church [11]. It seems to me that reconstructions like this which provoke questions would be better left on paper and not implemented on such a unique edifice.
