## Experimental Study on Seismic Behavior of High Strength Reinforced Concrete Frame Columns with High Axial Pressing Ratio

**Abstracts:** In order to research feasibility of high strength concrete applied to the main factory building frame and framed bent structure of large-scale firepower plant, based on the experimental research of 6 reinforced high strength frame slender columns under frequency cyclic loading, the failure shape and hysteretic characteristics were discussed. The main results show the surface concrete shedding of columns with high axial compression ratio and low hoop rate of the column drop more serious and those of columns with low axial compression ratio and high hoop rate drop slightly; with the decrease of axial compression ratio and stirrup ratio increases, the column hysteretic curve become increasingly full; the cumulative hysteretic energy become more and more big; the absorbed earthquake energy increases; the ductility also increases accordingly; whether high or low strength concrete frame column, with the axial compression ratio increases, the ductility decreases; the ductility of ordinary concrete columns is basically linear relation; the ductility of

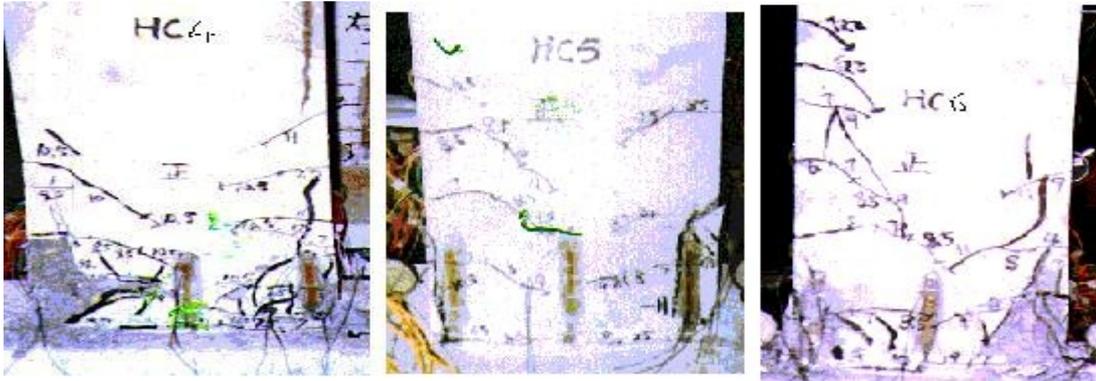
Fig.1 Damage picture of HC4 column Fig.2 Damage picture of HC5 column Fig.3 Damage picture of HC6 column

increased accordingly. Because the stirrup ratio and stirrup has no effect on the specimen cracking load, it can be considered that column cracking load and the axial load ratio have a certain relationship. A common law of development and the development of cracks of columns HC4、 HC5 and HC6 are: With the increase of load, the original cracks in the column left and right edges of different height range continued to extend forward. The downmost crack has been extended to the neutral axis and the uppermost crack from the original horizontal crack extended down from the top; a plurality of horizontal cracks through and not through cross section appeared at different height positions in the left and right column and then they extended to the left of column face. Then a plurality of vertical cracks appeared at the left or right lower edge of front column, and several vertical cracks also appeared at left or right side of column, which indicates that the concrete begin spalling and the test specimen reach its ultimate load. With the repeated load, there appeared concrete peeling in the column about two root area(see Fig.1, 2, 3) , the spalling concrete of column HC4, HC5 and HC6 aggravated and the development of cracks speeded up in order. The ruled of development and development cracks of columns HC7, HC8 and HC9 are: the original horizontal cracks appeared in the front or behind column continued, and at the same time there appeared new horizontal cracks at the upper part of the left or right side in the front or rear column; the development of the lower fracture is basically to the level of development; the development of the upper crack is the basic development from the top down. There appeared several vertical cracks at left or right edge in front or rear column and there also appeared a few vertical cracks in the column to the left or right, the concrete begin spalling and which indicates that the test specimen reach its ultimate load. With the repeated load, there appeared concrete peeling in the column about two root areas, the concrete of HC9 and HC8 column peeled severity and their crack development is also rapidly. When the HC7 column reached the ultimate load, starting repeated loading. Because of the less column reinforcement ratio and stirrup ratio, when repeated loading a cycle there appeared a huge burst of sound and the larger vertical displacement. The column occurred sudden bending

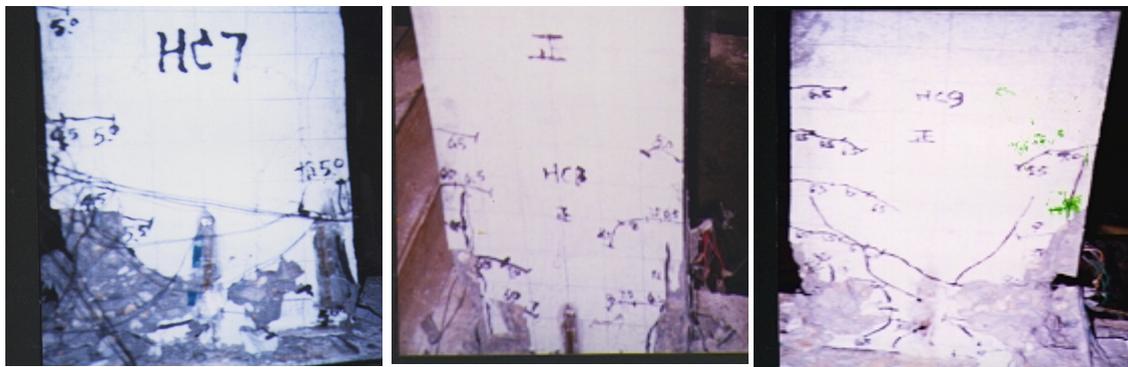
Fig.4 Damage picture of HC7 column Fig.5 Damage picture of HC8 column Fig.6 Damage picture of HC9 column

brittle destruction. Because of bending failure, the cracks is very wide; spalling concrete is very serious; spalling of concrete is serious at the high 0 ~ 25 cm in the front left margin; through the lower level around the crack(see fig.4).

The column HC8 and HC9 had some severe spalling of concrete at column root; some concrete had thin shedding phenomenon; even some reinforced in the roots all exposed (see fig.5 and 6). High strength concrete frame column subjected to complex and is destroyed in the common effect of the axial
