An Overview of Restoration Design and Technical Methods in the Conservation of Architectural Heritage

Keywords: Conservation of architectural heritage, Restoration design, Technology

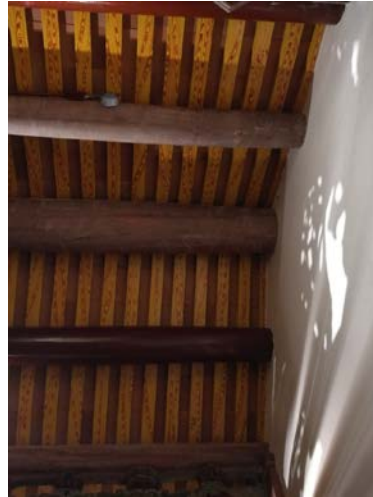
Fig. 1: Purlin used for replacement after restoration of Jiang's family temple

Strengthening of Beam. Beam splitting will have a variety of reasons, some because of the short duration of the use of wood is not dry, the surface and internal shrinkage deformation will be inconsistent, long old cracks; some of it is because the effect of termite infestation, wood from the inside of the hollow, in the long-term pressure bearing structure deformation cracks. For different reasons, different methods should be used to reinforce the structure. In case of harmfulness, need to clean the harmfulness, check the quality of wood can bear the load, according to fill the wood and glue adhesion, such as difficult to continue to use the need to replace the wood, try to choose the same or similar wood processing, according to the admission after replacing the original wood, as shown in Figure 1. In Japan, it creates a way to fit in. When the wood building materials must be replaced, they put the damaged wood removed, and then the wood fasteners tightening method with thousands of years ago to the reconstruction of the ancient buildings.

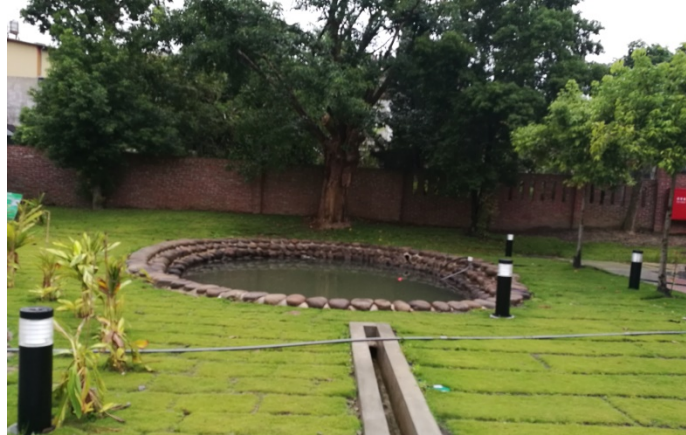
Fig. 3: Pool before the Jiang's family temple

For the restoration of historic buildings, the need to consider the risk of damage to the building itself, so the design should try to improve the preventive protection facilities, to prevent to protect buildings in unexpected incidents, reduce losses. For the construction of the site, need to take into account the harm caused by groundwater level terrain, avoid the water level, leading to the construction of basic structure damp, in the actual construction should not only reduce or discharge of groundwater, groundwater has established the detection pool or other equipment, to prevent water level due to rainfall increased, as shown in Figure 3. In order to detect the underground water level, the water reservation was protected before Jiang's temple. From the perspective of prevention, the lightning protection facilities reducing building lightning probability.
